SAFETY BULLETIN

Issued No: SMS/SB/02/2024

HANGAR 75 POST INCIDENT AND LESSON LEARNED

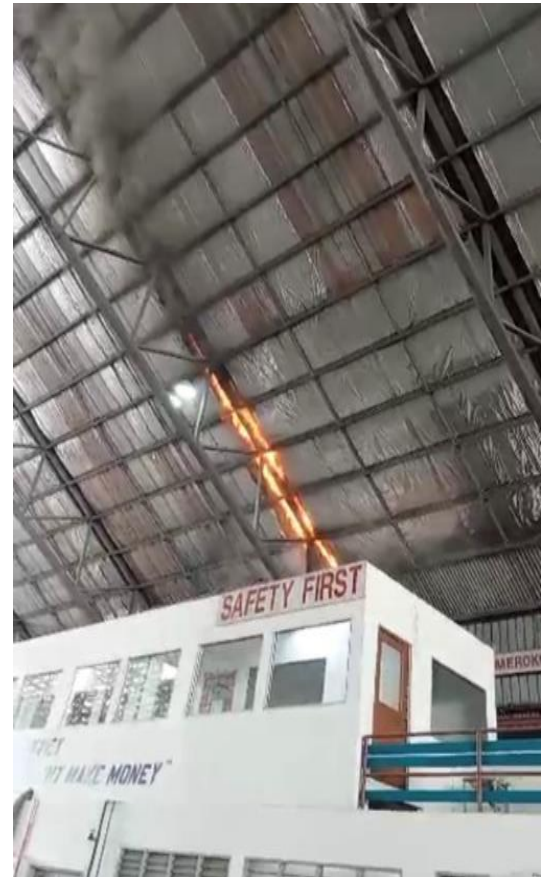
Following the fire incident at Hangar 75, several outcomes have ensued. ADE staff members were required to cease their work temporarily, necessitating a pause in their ongoing maintenance activities. Additionally, there was a need for the relocation of the affected line due to the repercussions of the incident. In addition, the ceiling within the technical representative room experienced a collapse, resulting in damage to various items within the office space. Moreover, a potential risk of roof leakage looms over the impacted area of Hangar 75, which could result in adverse consequences such as water damage to equipment, structural integrity issues, and the need for extensive repairs. The hangar floor of Hangar 75 was left in disarray following the fire incident, scattered with burnt residue from the ceilings.

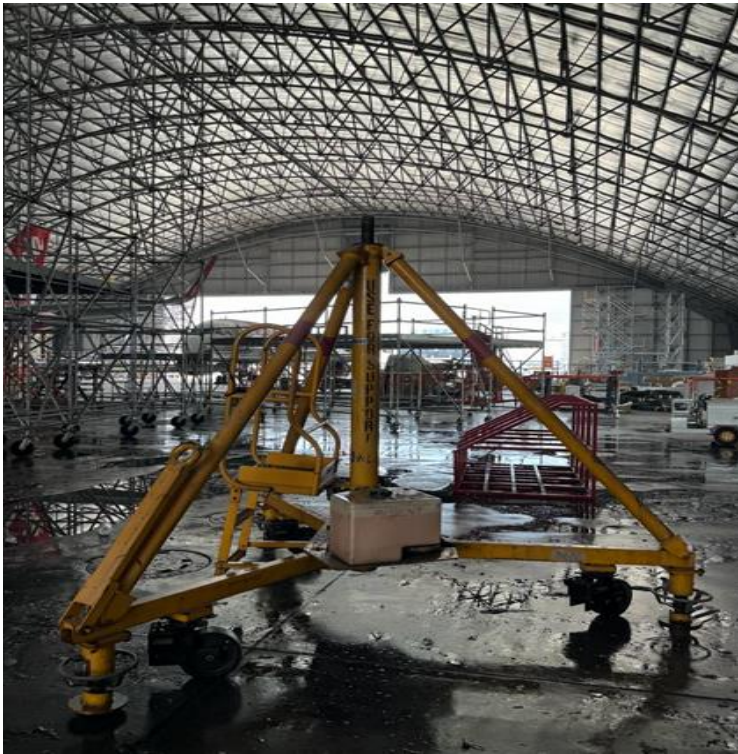
The absence of a comprehensive impact aspect study for the task involving the use of a weld torch to cut the structure has resulted in a critical oversight. This oversight has led to the exposure of plastic laminate concealed beneath the metal roof, causing it to absorb and melt due to the intense heat generated during the welding process, ultimately igniting a fire. The rapid spread of the fire was escalated by the combination of the laminated plastic and the presence of electrical conduit, creating a highly flammable environment that facilitated the swift escalation of the flames within a remarkably short time frame.
