SAFETY BULLETIN

Issued No: SMS/SB/02/2024

HANGAR 75 POST INCIDENT AND LESSON LEARNED

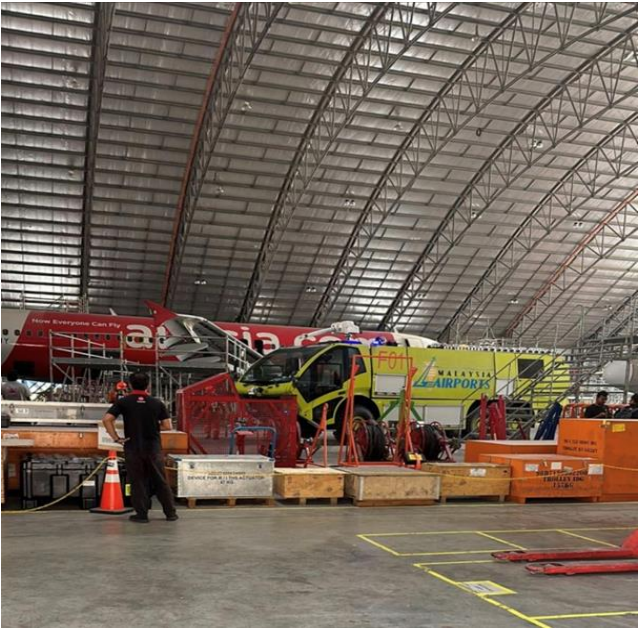
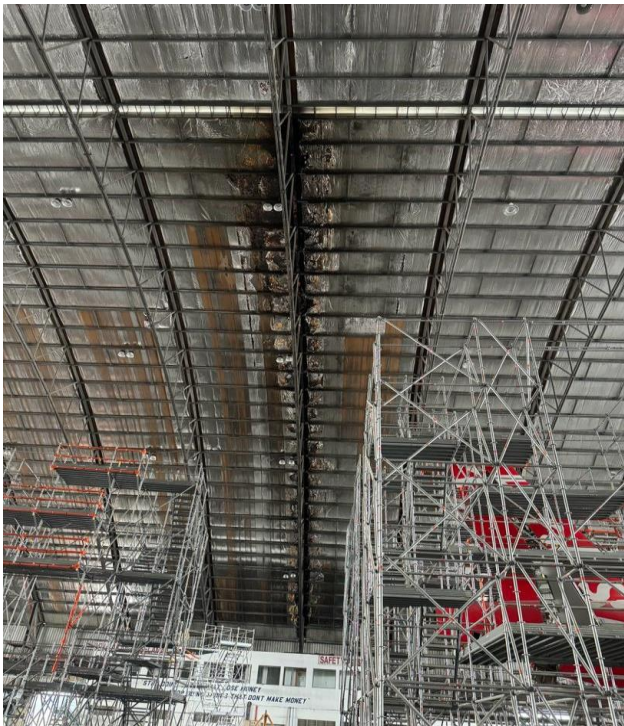
Fortunately, there were no injuries reported among the personnel, and the aircraft situated in the vicinity of the fire remained undamaged. The impact was confined to the specific rooftop of Hangar 75 where the welding repair activities were being carried out, resulting in limited damage to that particular area. The electrical conduit sustained damage, impacting the wiring on the roofs due to a fire incident. Consequently, in order to prevent electrical short circuits and mitigate potential further damage to the overall electrical system, it became necessary to shut down the electrical power supply at Hangar 75. In addition to the aforementioned, it was discovered that some of the items, including chairs, office computers, and carpets within the affected area were damaged. There is a suspicion that certain electrically powered equipment and other facilities within the hangar may have incurred slight damage as a result of the water discharged by the Aircraft Rescue and Firefighting Service (AFRS).

Following the fire incident at Hangar 75, several outcomes have ensued. ADE staff members were required to cease their work temporarily, necessitating a pause in their ongoing maintenance activities. Additionally, there was a need for the relocation of the affected line due to the repercussions of the incident. In addition, the ceiling within the technical representative room experienced a collapse, resulting in damage to various items within the office space. Moreover, a potential risk of roof leakage looms over the impacted area of Hangar 75, which could result in adverse consequences such as water damage to equipment, structural integrity issues, and the need for extensive repairs. The hangar floor of Hangar 75 was left in disarray following the fire incident, scattered with burnt residue from the ceilings.
